DEPARTMENT OF TRANSPORTATION

Quality Assurance and Source Inspection

Contract #: 04-0120F4Cty: SF/ALA Rte: 80 PM: 13.2/13.9File #: 69.28**WELDING INSPECTION REPORT****Resident Engineer:**Siegenthaler, Peter**Address:** 333 Burma Road**City:** Oakland, CA 94607**Report No:** WIR-019247**Date Inspected:** 14-Jan-2011**Project Name:** SAS Superstructure**OSM Arrival Time:** 700**Prime Contractor:** American Bridge/Fluor Enterprises, a JV**OSM Departure Time:** 1900**Contractor:** Zhenhua Port Machinery Company, Ltd (ZPMC), Changxing Island **Location:** Shanghai, China**CWI Name:** Lv Li Qing**CWI Present:** Yes No**Inspected CWI report:** Yes No N/A**Rod Oven in Use:** Yes No N/A**Electrode to specification:** Yes No N/A**Weld Procedures Followed:** Yes No N/A**Qualified Welders:** Yes No N/A**Verified Joint Fit-up:** Yes No N/A**Approved Drawings:** Yes No N/A**Approved WPS:** Yes No N/A**Delayed / Cancelled:** Yes No N/A**Bridge No:** 34-0006**Component:** OBG**Summary of Items Observed:**

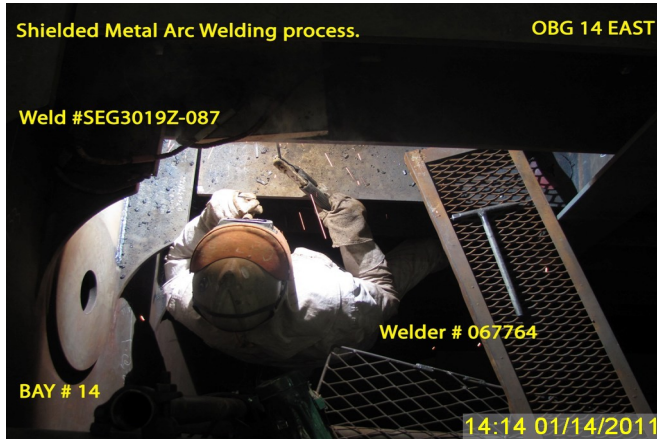
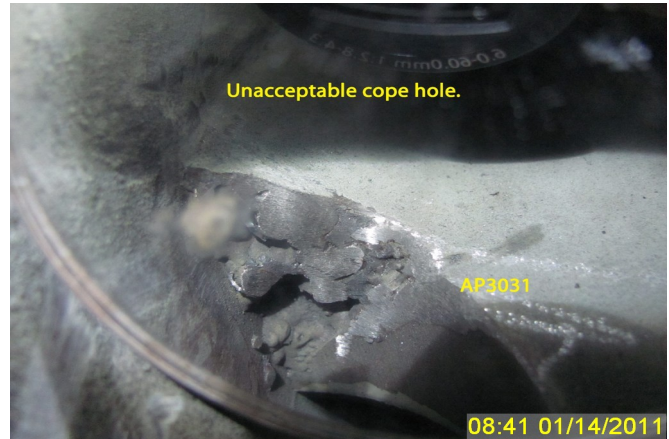
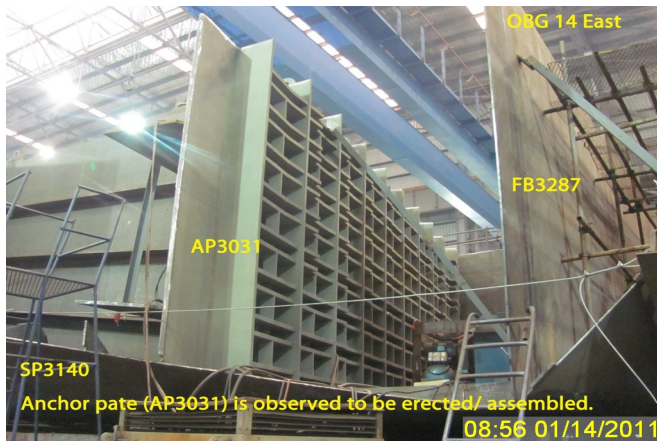
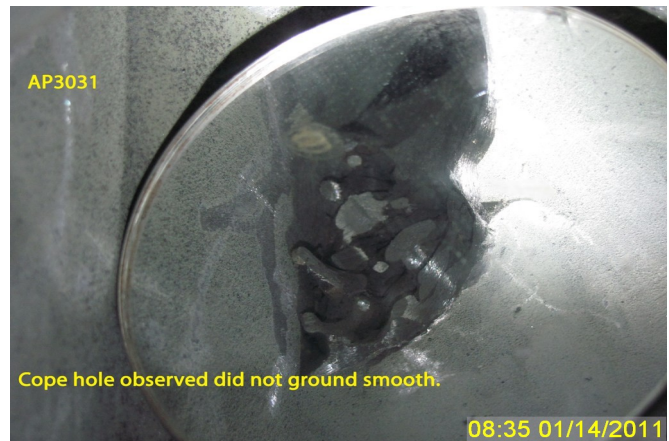
During the Quality Assurance (QA) random in-process observations of the fabrication of OBG 14 East in bay # 14, this Caltrans QA Inspector observed the Anchor Plate (AP3031) is observed to be erected/ assembled in OBG lift 14 East prior to correction of its cope holes.

The AP3031 located in OBG lift 14 east between PP126 and 126.5, The cope hole observed did not grounded smooth, slag, undercut, underfill, overlap likes discontinuity observed. See attached photos for more detail.

Incident report was issued.
